An Examination of Oxidative Passivated Surfaces on 19th Century Colt Revolver Barrels

by
MCKENZIE ALLISON FLOYD

SUBMITTED TO SCRIPPS COLLEGE IN PARTIAL FULFILLMENT OF THE
DEGREE OF BACHELOR OF ARTS

APRIL 27, 2012

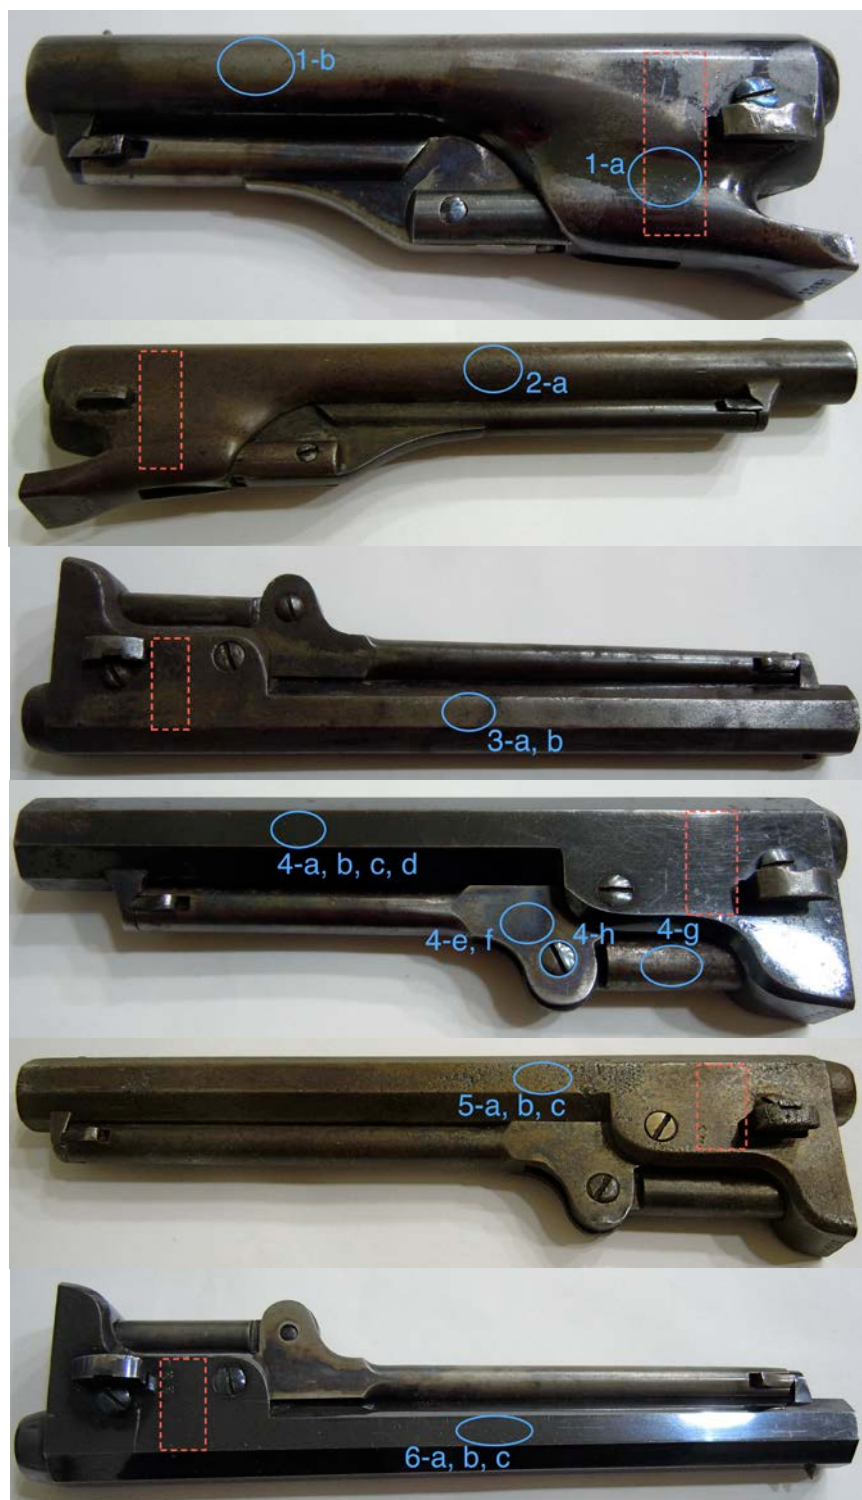
Figure 1 shows the six samples with locations of investigated areas marked according to technique. Where multiple areas on one sample have been measured with SEM-EDS, the areas have been denoted with letters, e.g. area **1-b** on **Sample 1**.

Figure 1. Six revolver barrel samples, numbered 1-6 in order from top to bottom. Areas marked with blue circles were analyzed with SEM-EDS, while those areas marked with red rectangles were analyzed with XRD.

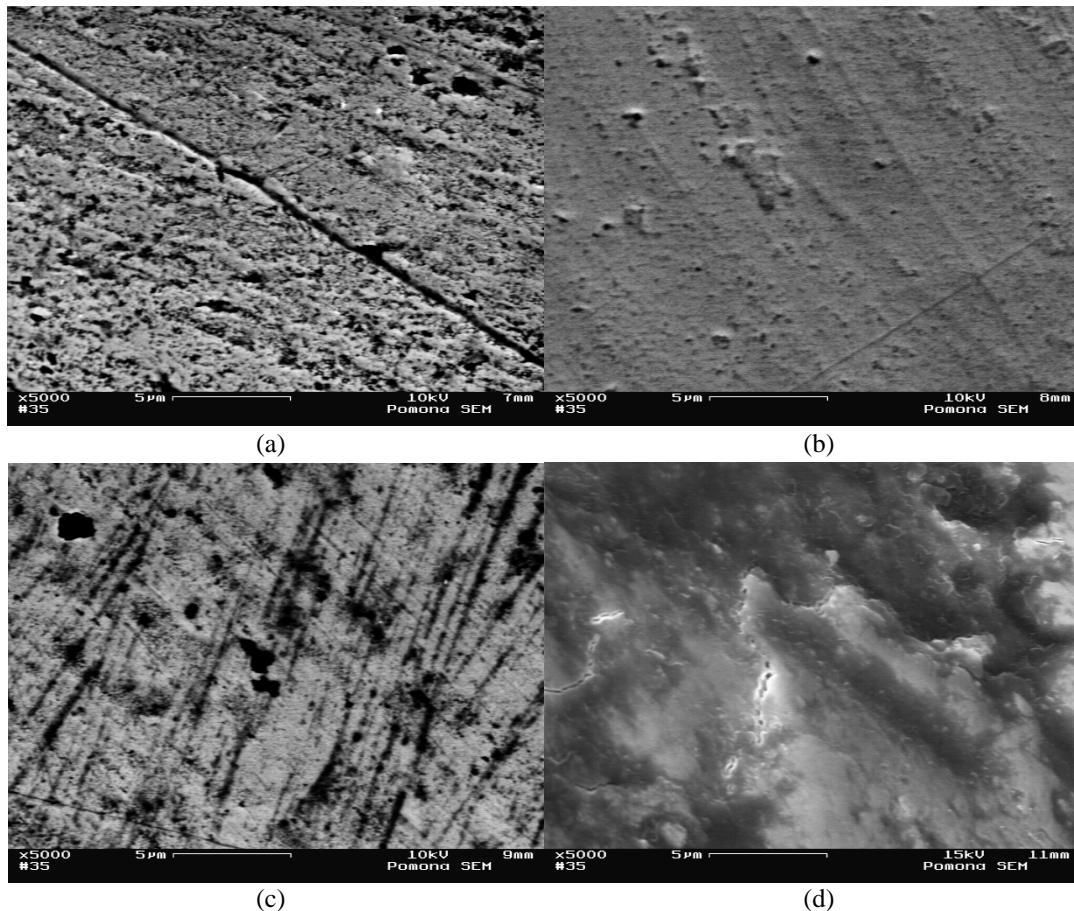
Figure 4 shows the morphology of well preserved barrel surfaces at 5000x magnification. The most well preserved blackened (magnetite) surfaces were on **Samples 1, 4, and 6**, while the least damaged browned (hematite) surface was that of **Sample 2**. SEM micrographs of the magnetite surfaces showed uniform topography with polishing scratches; comparison with secondary electron images taken by Tellèz and coworkers⁵ showed that the magnetite surfaces were in fact very close to how they would have appeared when the barrels were first manufactured. In contrast, no polishing scratches could be seen in the relatively amorphous hematite coating. However, the surface of the hematite film demonstrated larger variations in morphology than the magnetite films.

Figure 4. Well-preserved blackened (magnetite) surfaces on (a) Sample 1 (area 1-a), (b) Sample 4 (area 4-a), and (c) Sample 6 (area 6-a), and an intact browned (hematite) surface on d) Sample 2 (area 2-a) at 5000x magnification.

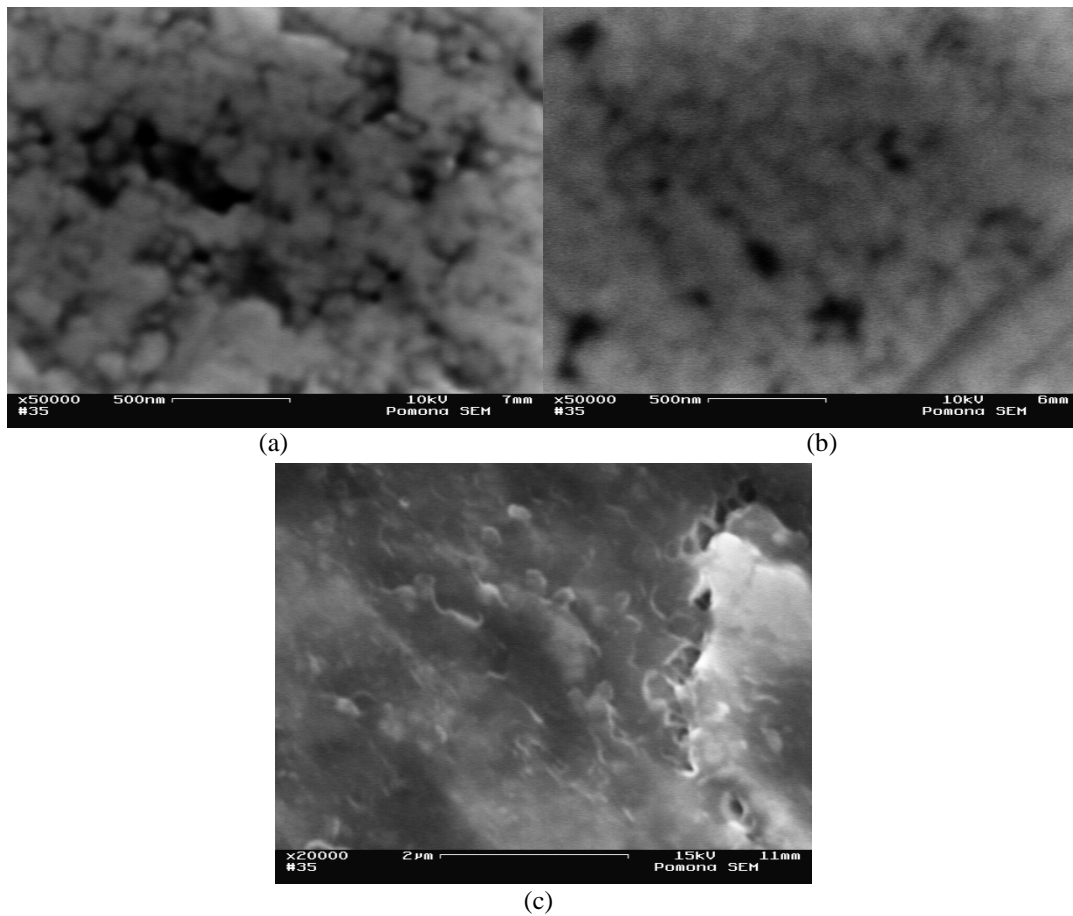
Higher magnification images of the magnetite surfaces revealed relatively homogenous, porous topography, characterized by round particles embedded in pockets that spread consistently across the surface (Fig. 5). These particles were on the scale of 50 nm, which is consistent with Cornell's description of magnetite particles produced by precipitation.⁶ Higher magnification of the browned surface on **Sample 2** showed in greater detail the amorphous topography of hematite.

Figure 5. 50000x magnification of magnetite grains on (a) area 1-a and (b) area 6-a. (c) 20000x magnification of hematite formation on (c) Sample 2, area 2-a.

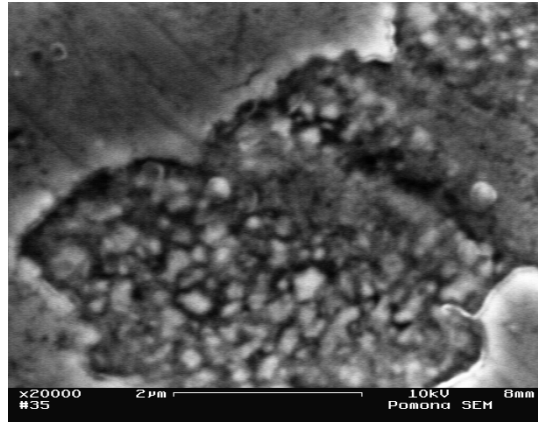
Damage to the well-preserved magnetite surfaces was minimal and occurred mostly in the form of small losses, such as that shown at 20000x magnification in Figure 6. Particles in the missing area were much larger than the magnetite film particles.

Figure 6. 20000x magnification SEM micrograph of magnetite loss on the surface of Sample 6.

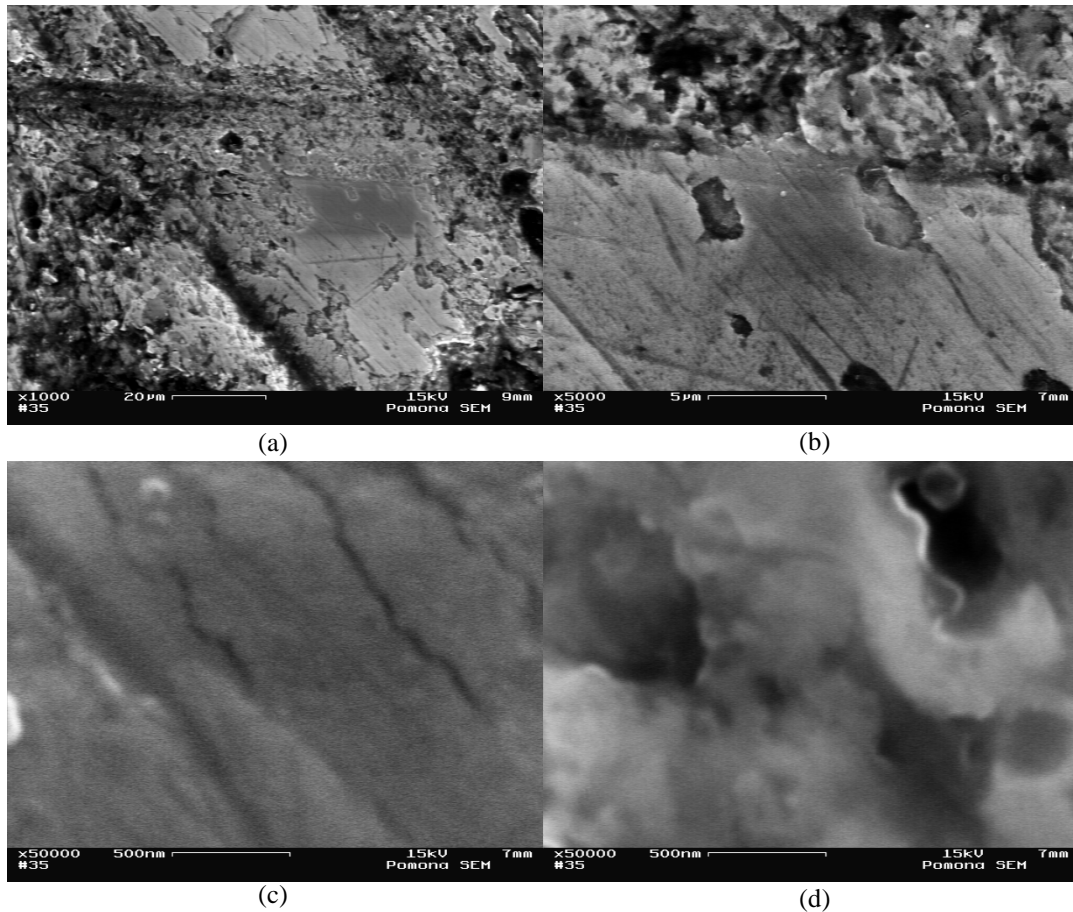
Sample 3 had many small, reflective areas, indicating that it was originally blackened, but underwent much wear over the years. Figure 7 shows increasingly magnified images of **Sample 3**, demonstrating where corrosion occurred. At 1000x magnification, the larger scratches caused by wear after its production were distinguishable from those on the magnetite surfaces in Figure 3, which were caused by polishing during production. Corrosive products appeared to have formed where the magnetite surface was scratched away. This is an example of “crevice attack,”⁶ which occurs where discontinuity in the surface increases the availability of corrosion reactants. Scratches to the magnetite film exposed the iron alloy beneath, leaving it susceptible to corrosive attack.

Figure 7. SEM micrographs of area 3-a at (a) 1000x magnification, (b) 5000x magnification, (c) magnetite at 50000x magnification, and (d) corrosion product at 50000x magnification.

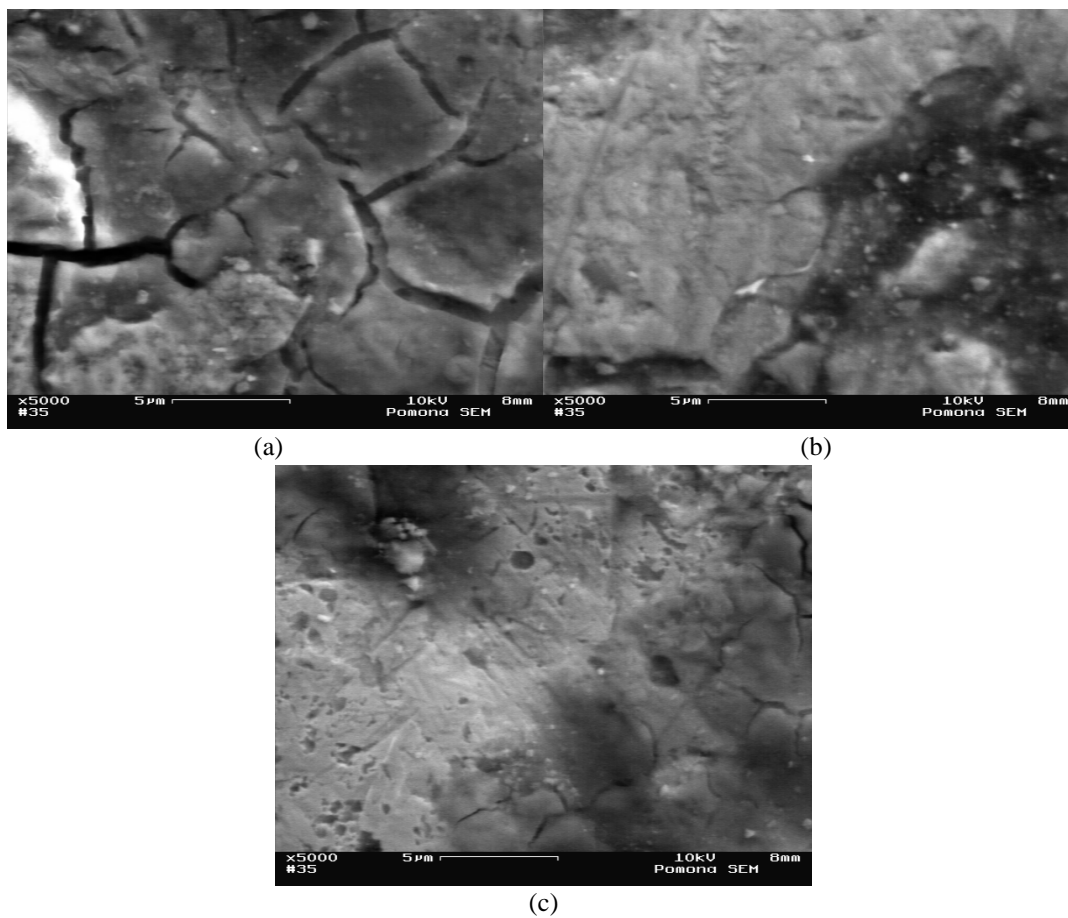
Sample 5 was the more damaged of the two browned samples, with extensive pitting across much of its surface. Three different SEM micrographs of one area (Fig. 8) demonstrate the various types of corrosion that can occur on such an artifact. Figure 8a shows cracks in the oxide patina as well as debris. Unlike losses to the magnetite films, pits in the surface on browned samples did not have defined edges (Fig. 8b). Areas of plain steel (Fig. 8c) were also present.

Figure 8. 5000x magnification SEM micrographs of areas (a) 5-a, (b) 5-b, and (c) 5-c. Each of these micrographs were taken from the same general area of Sample 5.

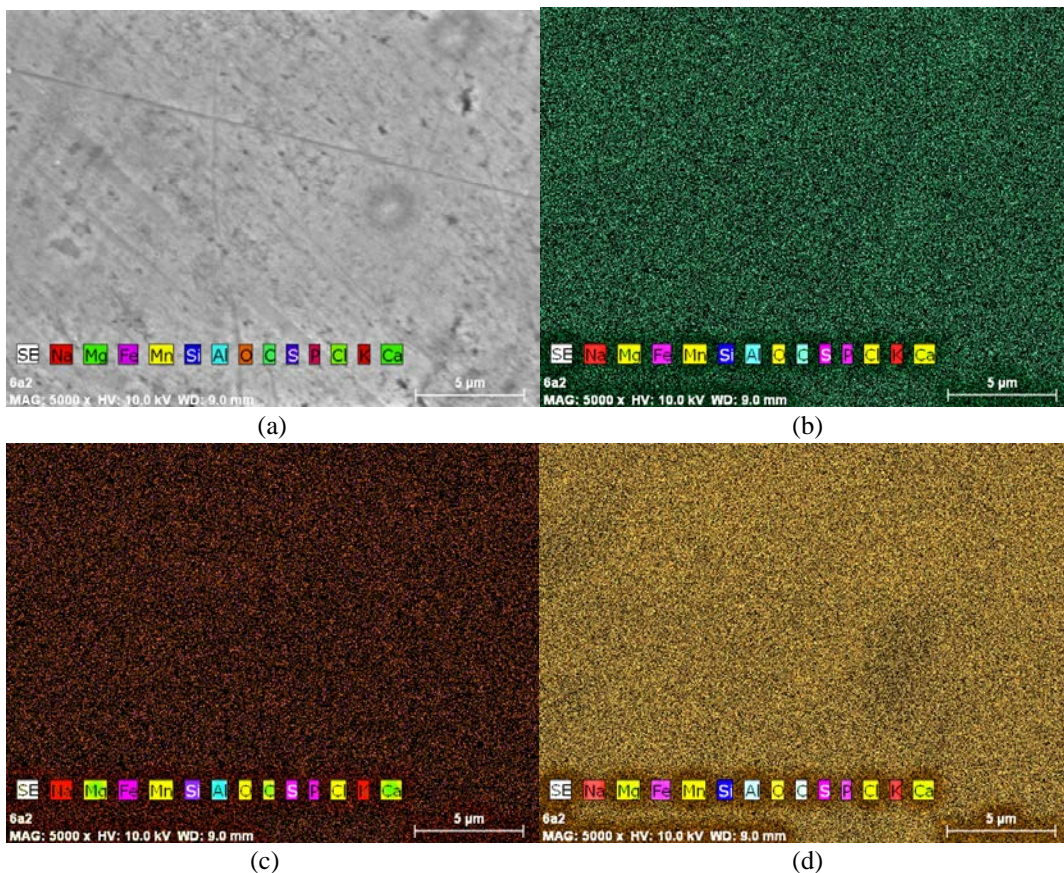
Figure 10. Secondary electron image (a) and elemental maps of (b) carbon, (c) oxygen, and (d) iron on well-preserved blackened (magnetite) surface on area 6-c.

elemental maps for area **6-b** demonstrated the type of formations common for the well-preserved blackened (magnetite) surfaces (Fig. 10). The blued surface, **1-b**, which also consists of magnetite, had patterns similar to those of the blackened surfaces.

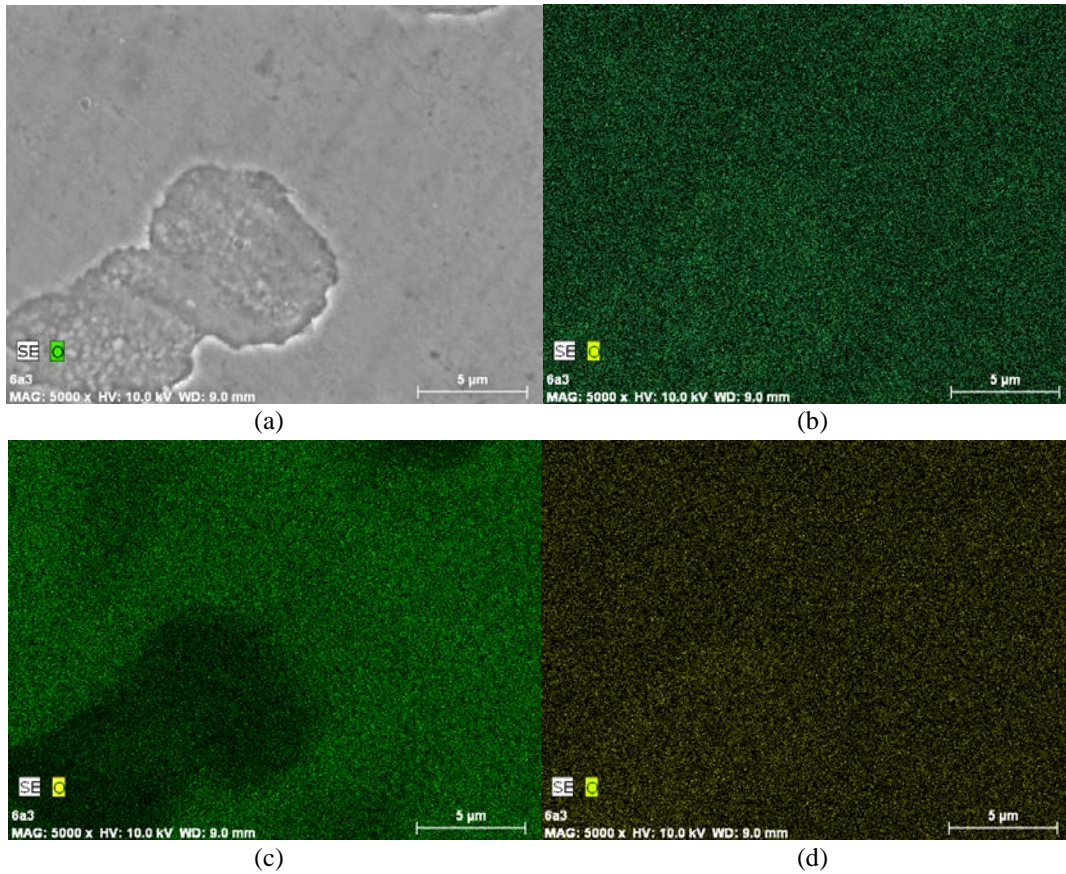
Figure 11. Secondary electron image (a) and elemental maps of (b) carbon, (c) oxygen, and (d) iron on well-preserved blackened (magnetite) surface with some loss on Sample 6-c.

The secondary electron image and elemental maps of area **6-c** (Fig. 11) demonstrated one type of loss that occurs on well-preserved blackened samples. The level of oxygen was significantly lower in the area of damage when compared to the intact magnetite film (Fig. 5b). This indicates that this area was loss rather than corrosion, for a rusted area would have had a relatively higher amount of oxygen (Fe_2O_3 or other

oxides) than the magnetite surface (Fe_3O_4) or steel (Fe-C alloy). These small losses were common on the magnetite surfaces analyzed in this study.

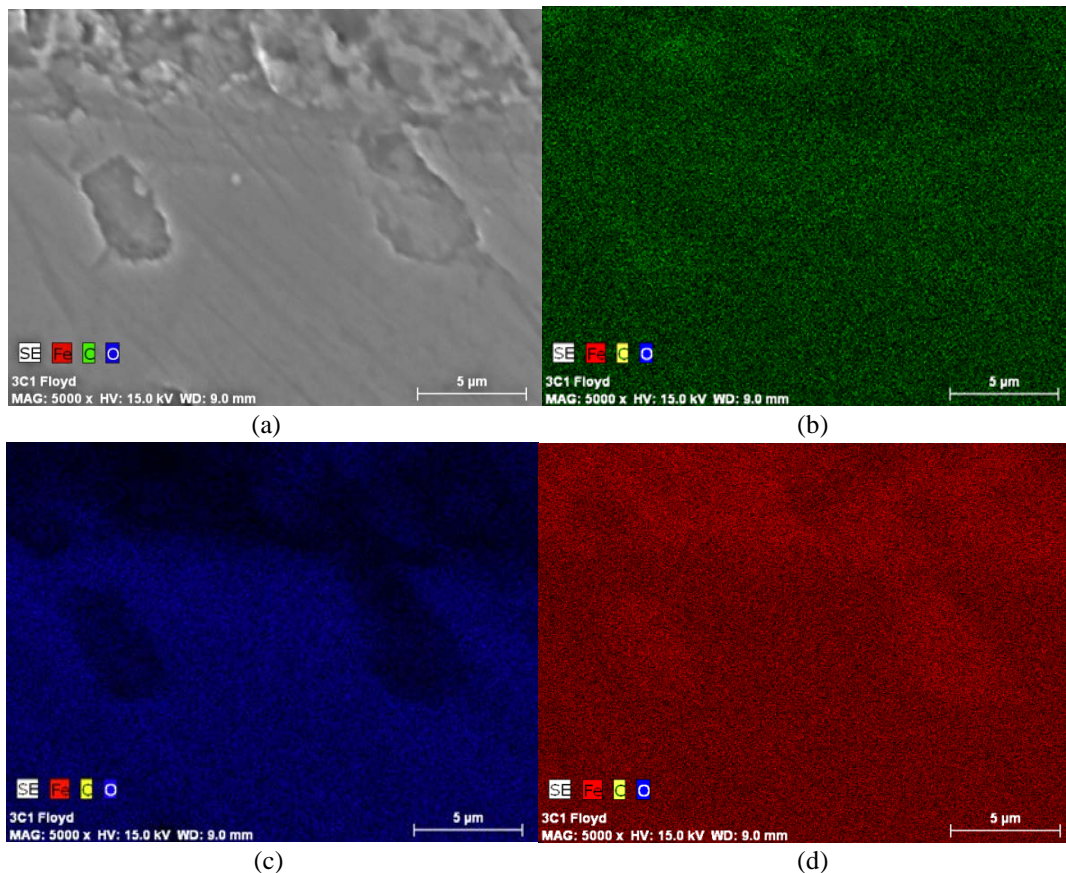
There were, however, corroded areas on the magnetite surfaces that showed evidence of oxides besides Fe_3O_4 . The scratched and worn surface of **Sample 3** had both types of damage: loss and corrosion. Elemental maps of area **3-a** showed a decrease in oxygen levels in the small areas of loss similar to those on **Sample 6**. The scratched area contained oxygen and high levels of iron, indicating the presence of iron oxides and plain steel (Fig. 12).

Figure 12. Secondary electron image (a) and elemental maps of (b) carbon, (c) oxygen, and (d) iron on the edge of a blackened (magnetite) surface on area 3-a.

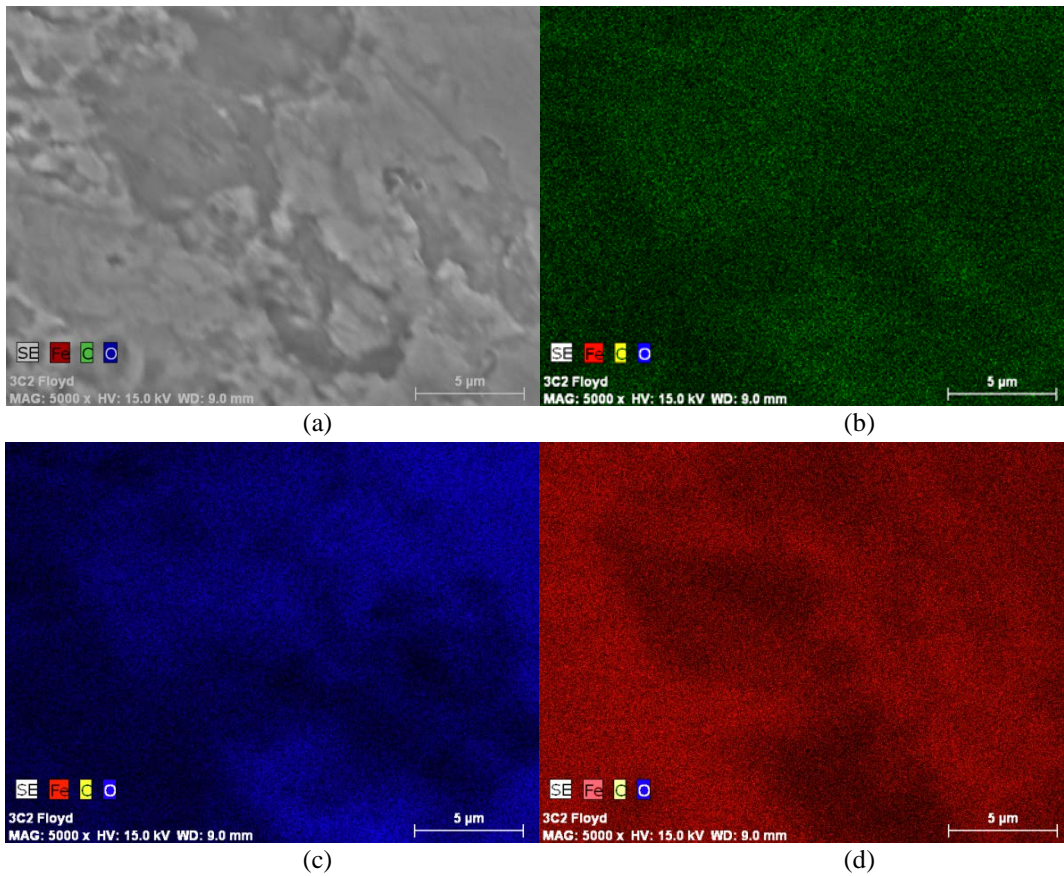
Figure 13 shows an area of **Sample 3** with extensive corrosion. Areas with high levels of oxygen coincided with the presence of iron oxides. Higher levels of carbon were also present in the corroded areas compared with preserved magnetite areas. Although the losses were jagged and less contained than previous examples, they were nevertheless easily distinguishable from the surrounding magnetite film.

Figure 13. Secondary electron image (a) and elemental maps of (b) carbon, (c) oxygen, and (d) iron on the edge of a blackened (magnetite) surface on area 3-b.

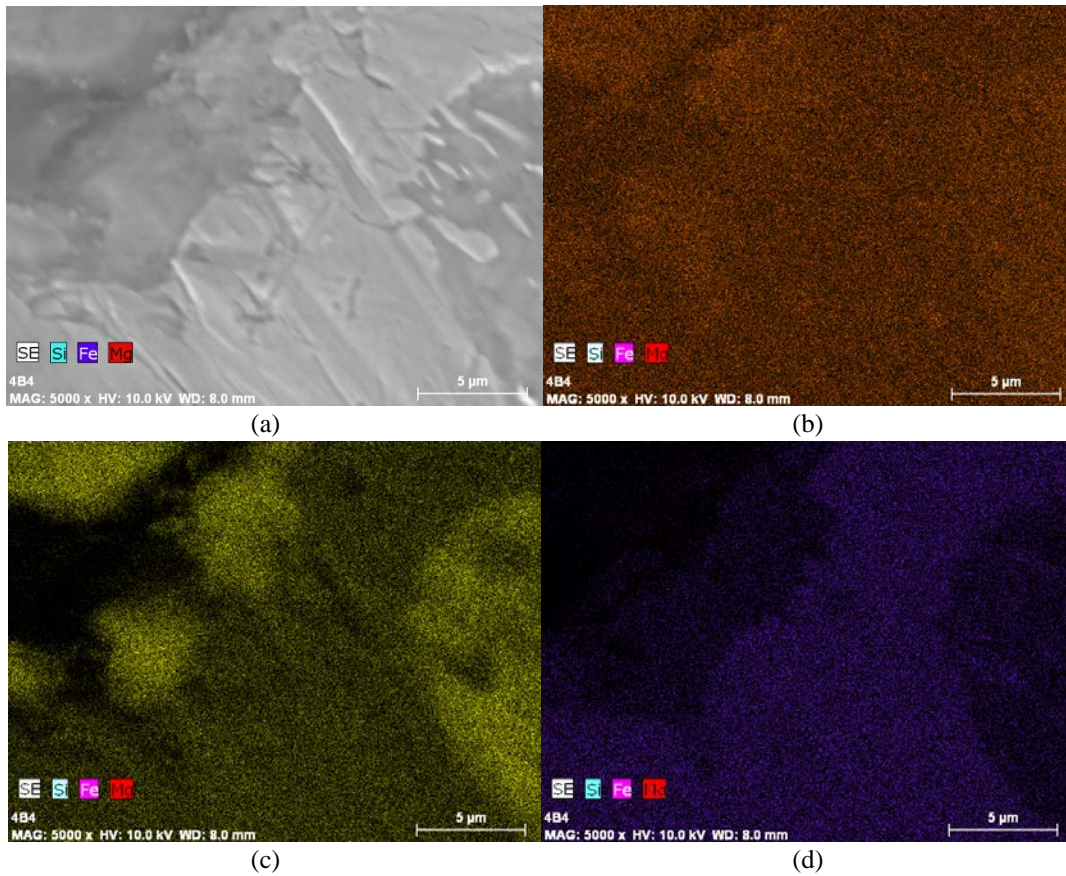
Even those blackened samples with good-condition magnetite films had areas of serious corrosion. These areas were present on the edges of the octagonal barrels, where the surface was most likely to be scratched and worn. The EDS maps of area **4-d**

demonstrated this (Fig. 14). Figure 14c shows that more oxygen-rich compounds were present in the damaged areas. However, although higher oxygen levels were present in the damaged areas, the distribution of carbon (Fig. 14b) and iron (Fig. 14c) complicated the exact nature of the oxides. The presence of carbon was possibly due to the deposition of carbonaceous debris over time.

Figure 14. Secondary electron image (a) and elemental maps of (b) carbon, (c) oxygen, and (d) iron on the edge of a blackened (magnetite) surface on area 4-d.

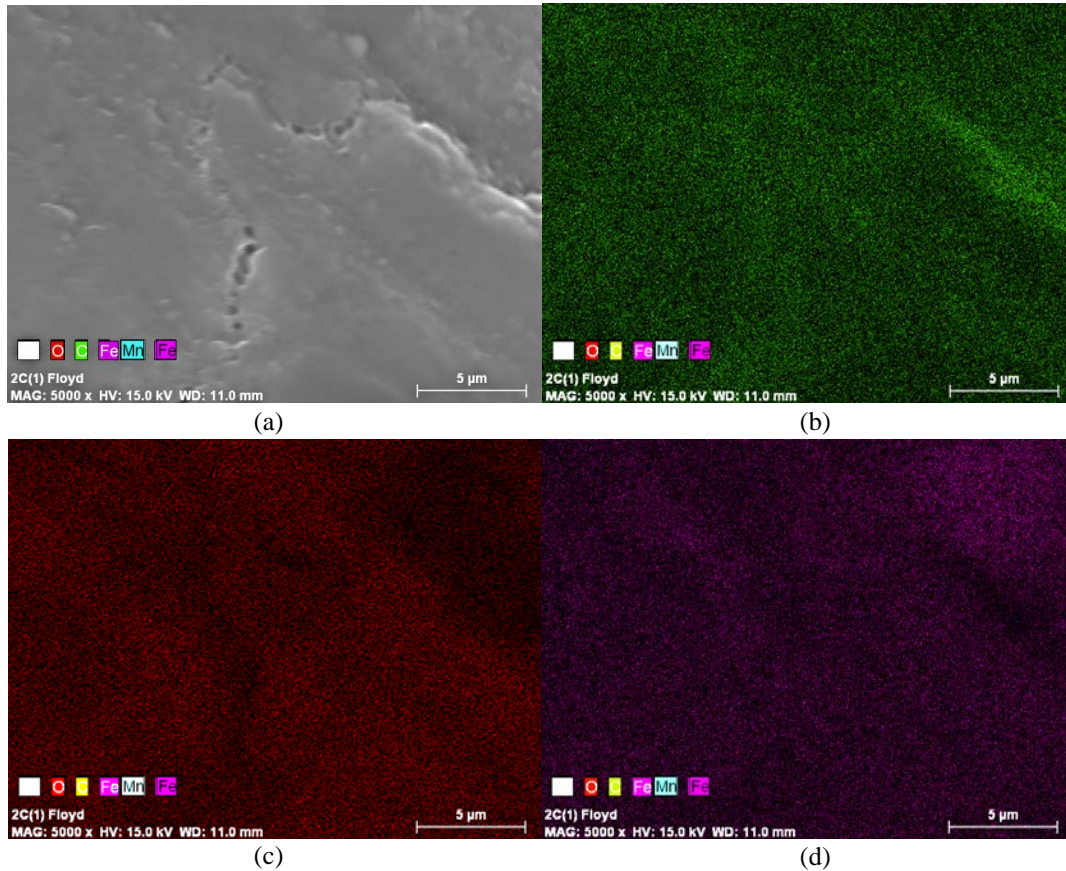
The hematite surfaces, as discussed above, were less morphologically uniform than the magnetite surfaces. This was also reflected in the variegating patterns revealed in EDS elemental maps (Fig. 15). Minor crack-like morphologies were present (Fig. 15a).

Lower oxygen levels along these cracks showed that they were breaks in the oxide surface. The uneven distribution of Fe, C, and O on even the better-preserved hematite areas could have been due to the fact that hematite forms non-uniformly across the surface during chemical treatment.

Figure 15. Secondary electron image (a) and elemental maps of (b) carbon, (c) oxygen, and (d) iron on a browned (hematite) surface on Sample 2.

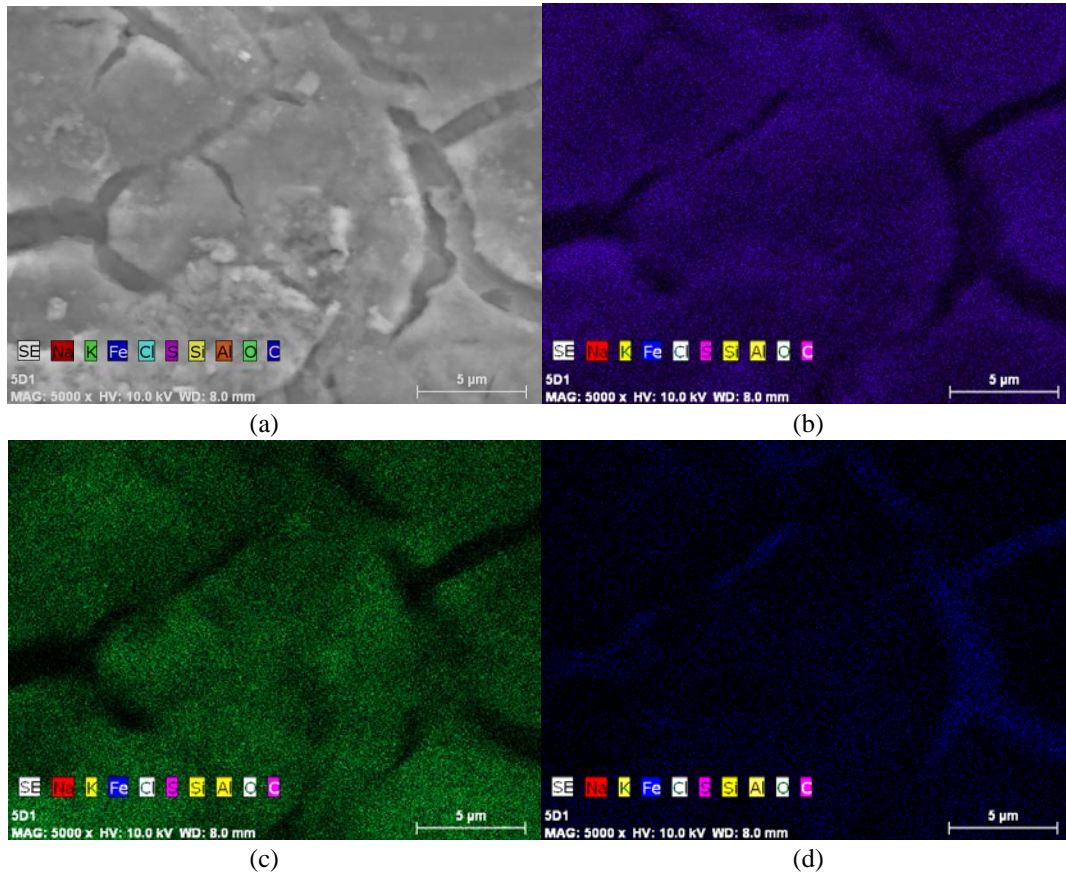
Figure 16. Secondary electron image (a) and elemental maps of (b) carbon, (c) oxygen, and (d) iron on browned (hematite) surface on area 5-c.

Figure 16 shows more carbon and oxygen in the crust, while high levels of iron were present in the cracks. Here, the oxygen- and carbon-rich crust pulled away to reveal the steel beneath. The chemical similarity of the hematite coating and the corrosion products make it difficult to assess the exact failure mode of the coating in this instance.

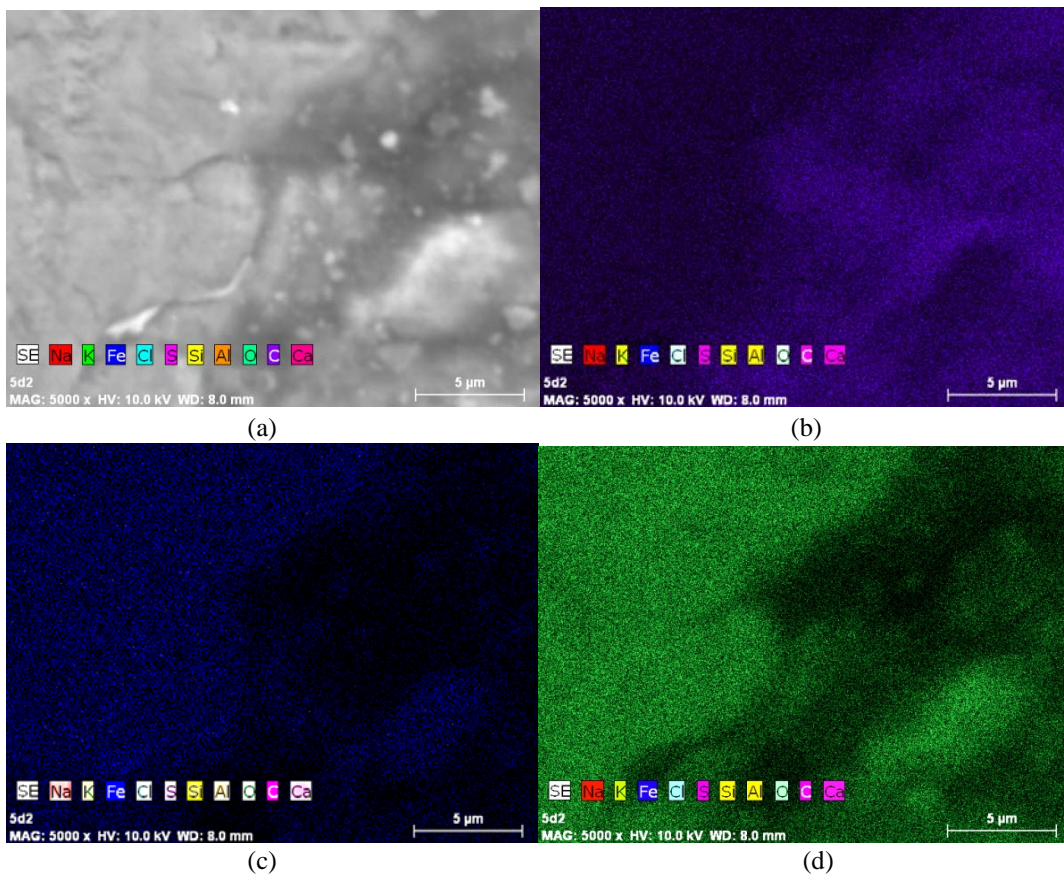
Characteristic of these areas of high corrosion on hematite samples was the large amount of debris. In some areas, this could be readily identified as carbonaceous material

by relatively high levels of carbon in areas of almost no iron or oxygen (Fig. 17). Together, figures 17a and 17b demonstrate the aggregation of carbonaceous materials in areas of surface loss. Such materials presumably accumulated over the lifetime of the object, likely from the application of lubricants. These lubricants would have prevented further corrosion, which was evidenced by the lack of oxides present in the carbonaceous area (Fig. 17c).

Figure 17. Secondary electron image (a) and elemental maps of (b) carbon, (c) oxygen, and (d) iron on browned (hematite) surface on area 5-b.

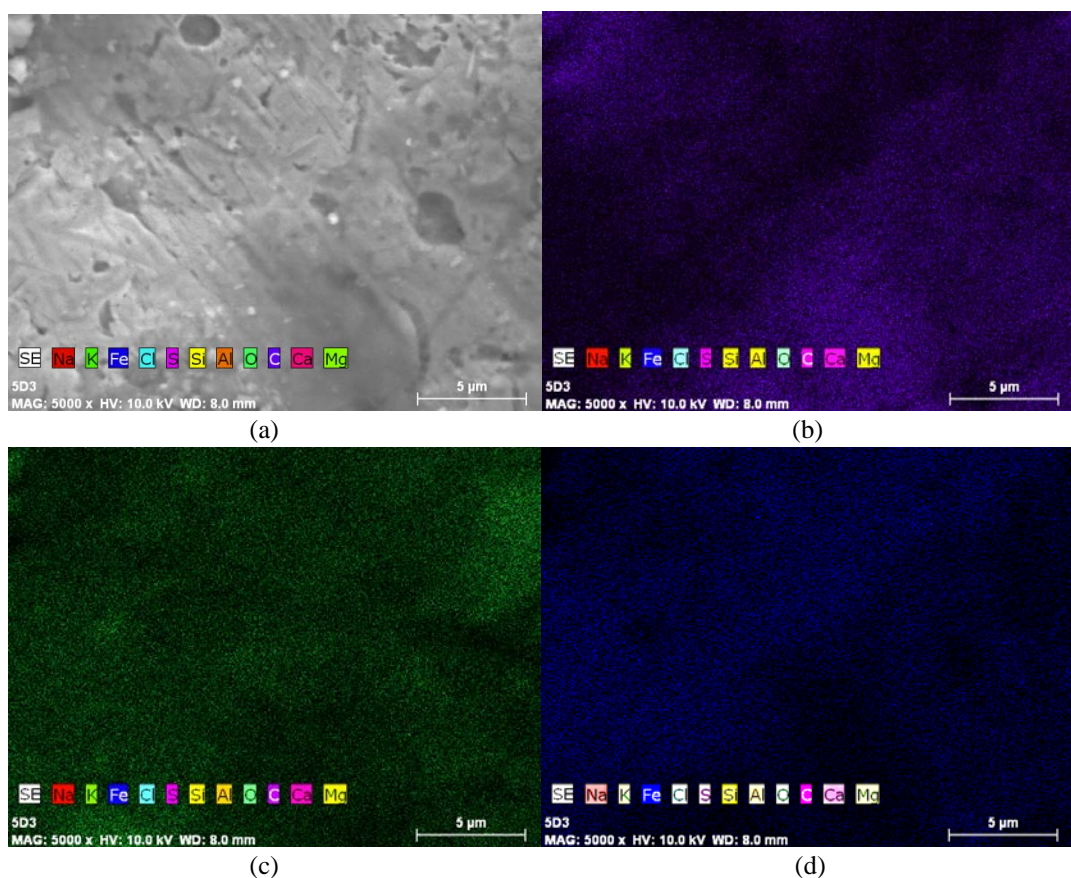
Figure 18. Secondary electron image (a) and elemental maps of (b) carbon, (c) oxygen, and (d) iron on browned (hematite) surface on area 5-c.

The distribution of iron in area **5-c** (Fig. 18d) coincided with the XRD and EDS elemental abundance findings of a large, sharp Fe peak (XRD) and high iron abundance (EDS) with little to no evidence of hematite present (XRD or EDS). This sample location was primarily made up of exposed steel, the morphology of which could be seen in the secondary electron image (Fig. 18a). This area demonstrated how losses in the oxide patina on the browned samples were much less well-defined than those on the blackened samples, sometimes resulting in the total loss of the original hematite protective coating.
