An Examination of Oxidative Passivated Surfaces on 19th Century Colt Revolver Barrels

by
MCKENZIE ALLISON FLOYD

SUBMITTED TO SCRIPPS COLLEGE IN PARTIAL FULFILLMENT OF THE
DEGREE OF BACHELOR OF ARTS

APRIL 27, 2012

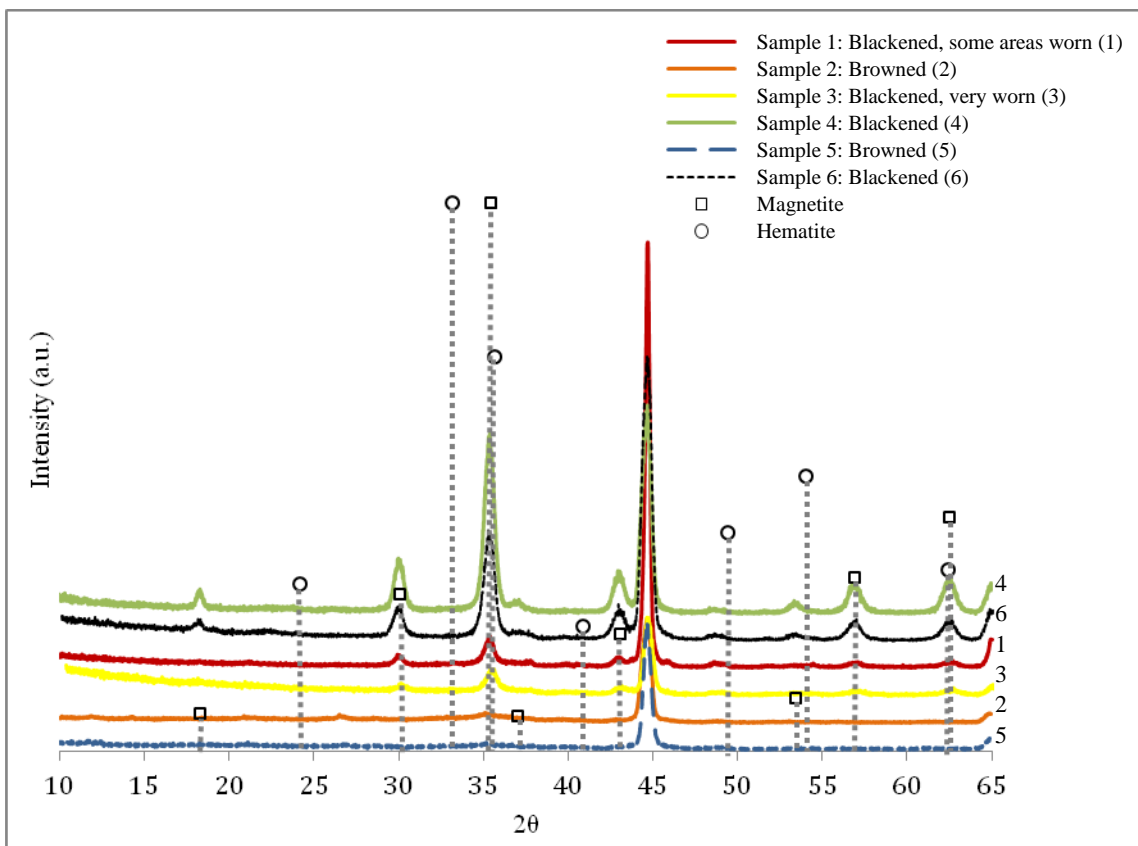
Figure 3 shows XRD diffraction patterns of the six samples, overlaid with reference patterns for magnetite and hematite.¹⁵ **Samples 4** and **6** had well preserved blackened surfaces, and their diffraction patterns showed tall, sharp peaks consistent with magnetite. **Samples 1** and **3** were both blackened as well, but their magnetite surfaces were largely scratched or worn away. X-ray diffraction patterns of these samples showed that magnetite is present, although the peaks were not as intense as those of the well-preserved samples. The diffractogram of **Sample 1** showed only a large iron peak, indicating that the areas worn away were likely free of other crystalline species, e.g., hematite.

Figure 3. XRD diffractograms of Samples 1-6, with overlaid patterns of hematite and magnetite.

It has previously been observed that neither hematite nor magnetite can be identified on chemically treated samples.⁵ Although the chemically treated browned barrels (**Samples 2** and **5**) did have small peaks consistent with magnetite, they were wide and shallow, indicating a mostly amorphous surface with very small crystallites. The relatively good condition of **Sample 2** in comparison to **Sample 5** may have contributed to the slightly stronger peaks. Hematite could not be identified on any of the samples. The presence of strong magnetite peaks on **Samples 1, 3, 4, and 6** showed that these barrels were thermally treated, which confirmed historical assessment of patination methods used by the Colt Patent Arms Manufacturing Company.

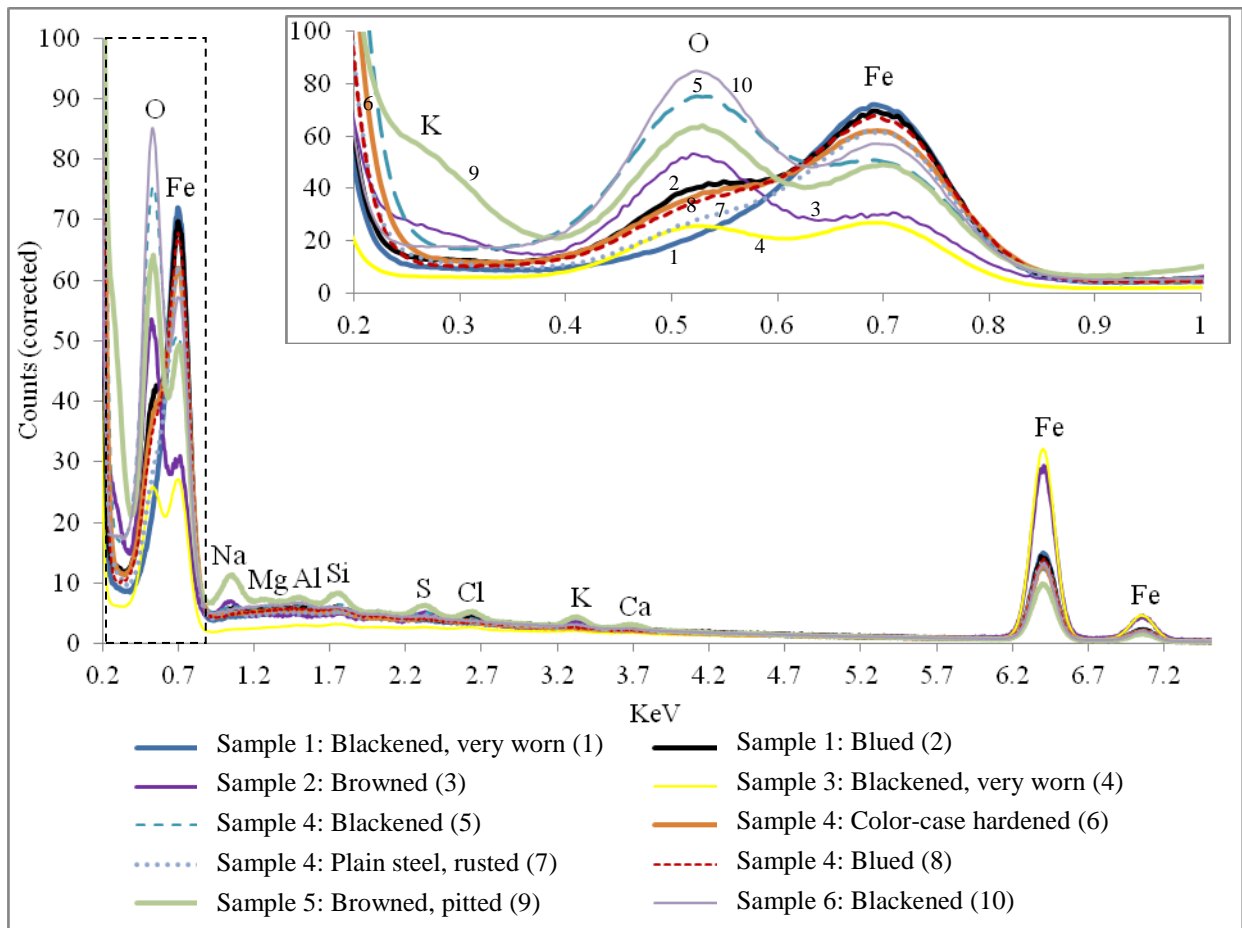
Figure 9 depicts trends associated with the relative abundance of oxygen and iron according to the type of surface. Well-preserved magnetite surfaces had relatively high peaks for oxygen and mid-range iron peaks. Worn and unpassivated surfaces had large peaks for iron, and small or no peaks for oxygen. The spectra of the browned surfaces possessed peaks for K, Na, Mg, Al, Si, S, Cl, and Ca, while those of the blackened surfaces did not. The presence of these elements may be attributed either to their preparation in chemical solutions, or the aggregation of debris over the past 150 years.

Figure 9. EDS spectra of areas on Samples 1-6. Peaks identified using Bruker ESPRIT software for EDS. Spectra for Samples 3, 4, 5, and 6 are averages of multiple EDS spectra in order to show general trends. Inset graph corresponds to dashed box on the main spectrum.

Table 2 summarizes the elemental abundance of various EDS mapped surfaces on each of the samples. The most oxygen-deficient areas (areas **1-b**, **4-f**, **4-g**, **4-h**, and **5-c**) were those with the most wear, or those that were never patinated, e.g., color-case hardened pieces. The low abundance of oxygen (1.70%) and high abundance of iron (94.66%) on area **1-b** is consistent with the XRD data regarding this area. The presence of nitrogen is generally associated with areas that have intact magnetite films. The elements Na, Mg, Al, Si, P, S, Cl, K, and Ca were most prevalent on the browned surfaces as seen in the EDS spectra. These ions could be present from the chemical solutions used to produce the browned surfaces; Angier includes many compounds which include these species in his list of common acids and salts used for browning solutions.⁶ The presence of these elements could also be due to the debris seen in the SEM images of the browned surfaces. Area **5-c** had a higher level of oxygen than **5-a** and **5-b**, an observation consistent with both the SEM micrographs of these areas and their EDS maps (see below), which show area **5-c** as a more pristine surface location. The relative consistency of Cr abundance could indicate that the steel alloys used to make the firearms contained small amounts of the metal.
